*Proton Source Department*

**20<sup>th</sup> ICFA Workshop on High Intensity  
and High Brightness Hadron Beams  
Fermilab  
April 8-12, 2002**

**Fermilab Booster Beam Loss and Collimation**

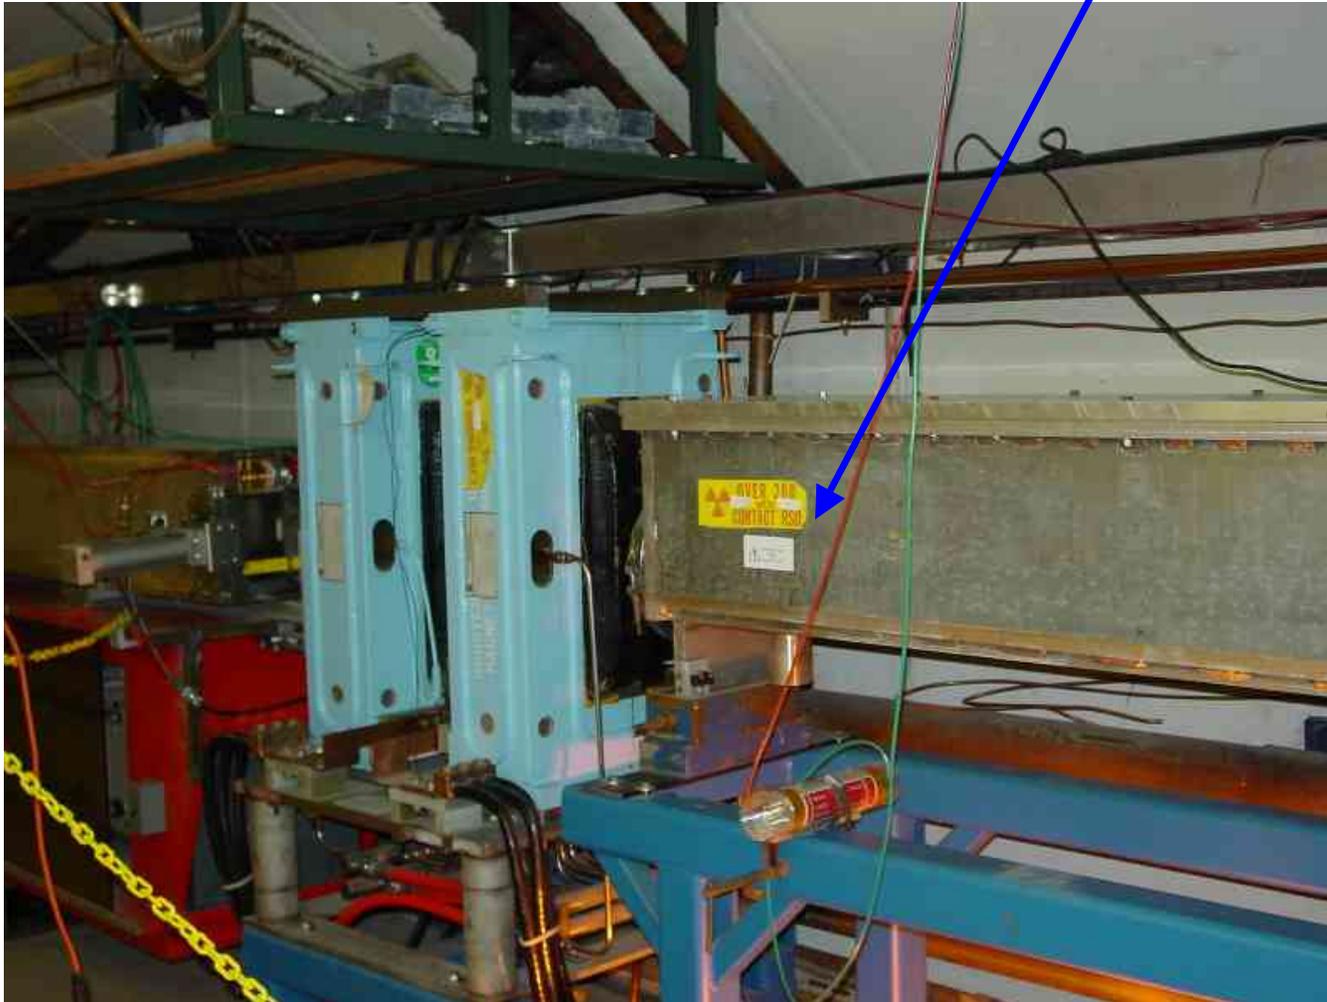
## Extraction Survey Point (@ 1 foot)

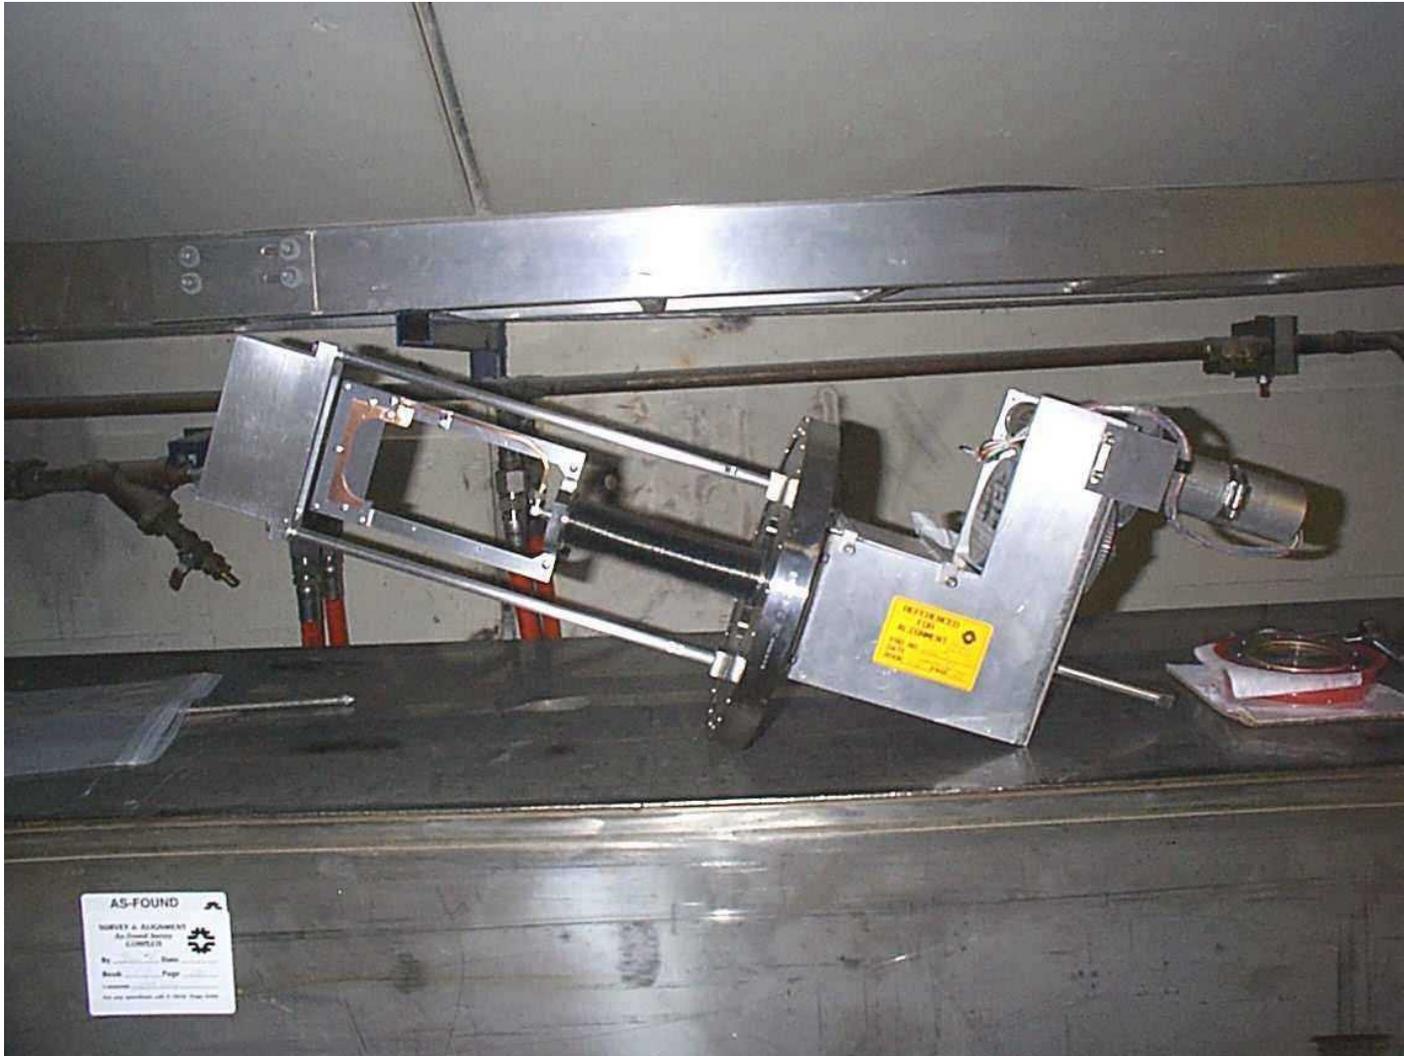
# Primary Collimator

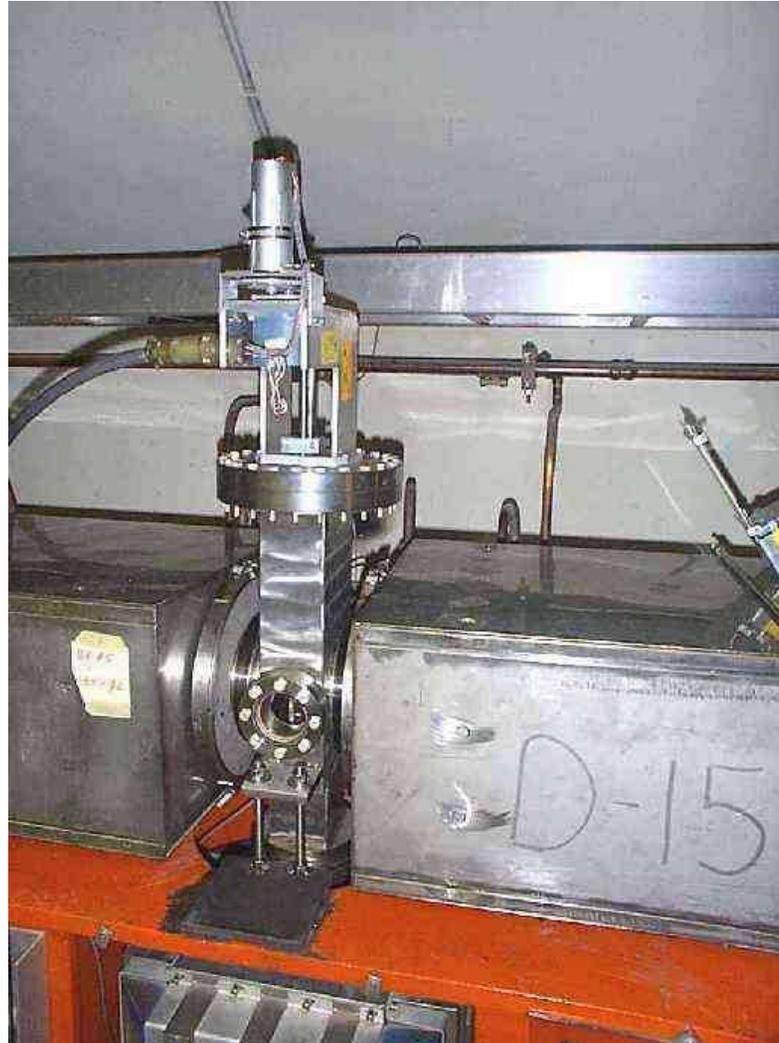
# Vertical Primary Collimator Installation

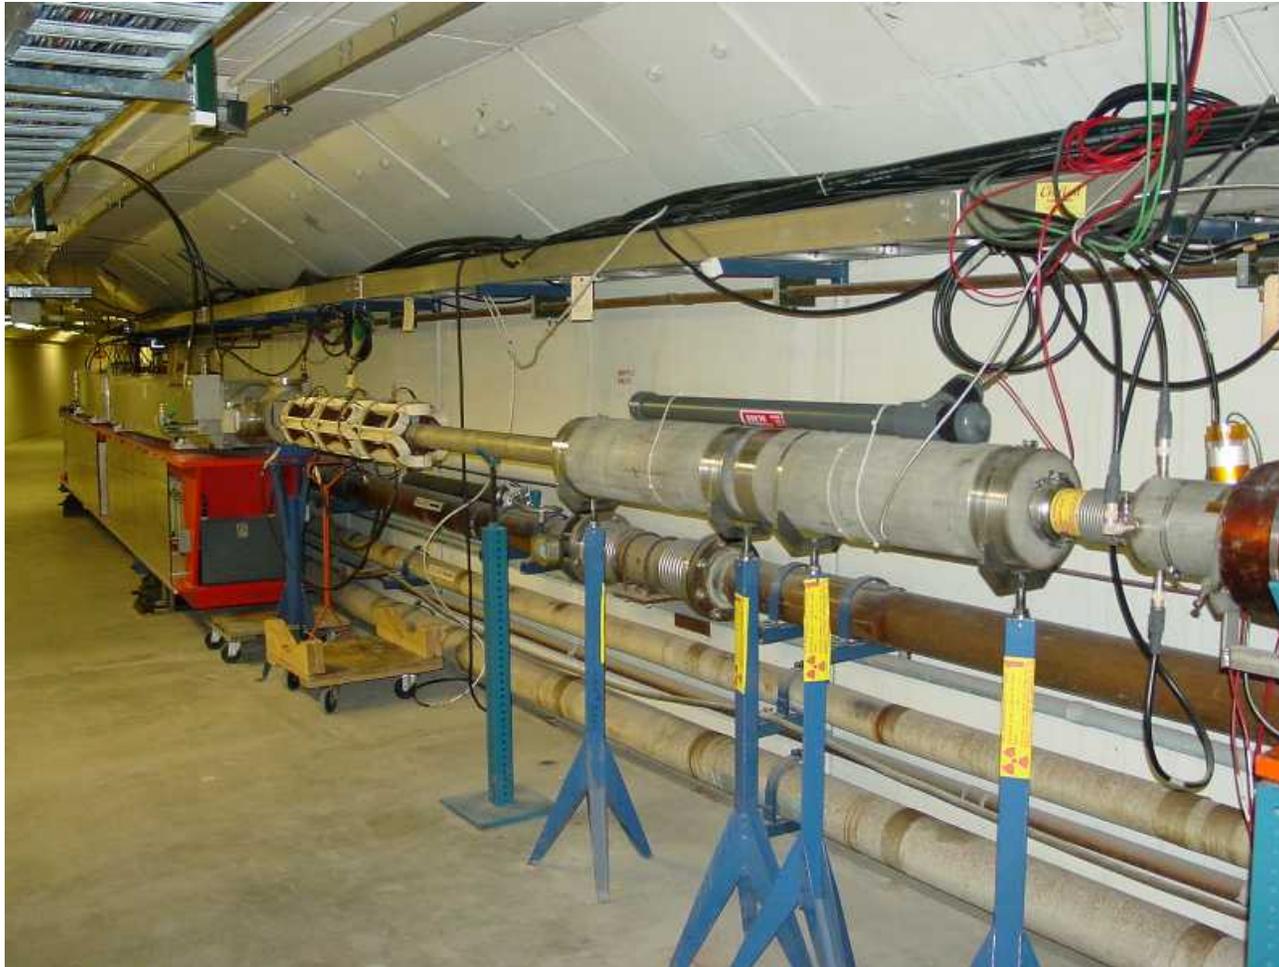
# Inductive Inserts in Booster (installed 10/01)
